Miscellaneous Paper SL-98-1
January 1998

Investigation of Concrete from I-20 Near Monroe, Louisiana

by G. Sam Wong

Final report

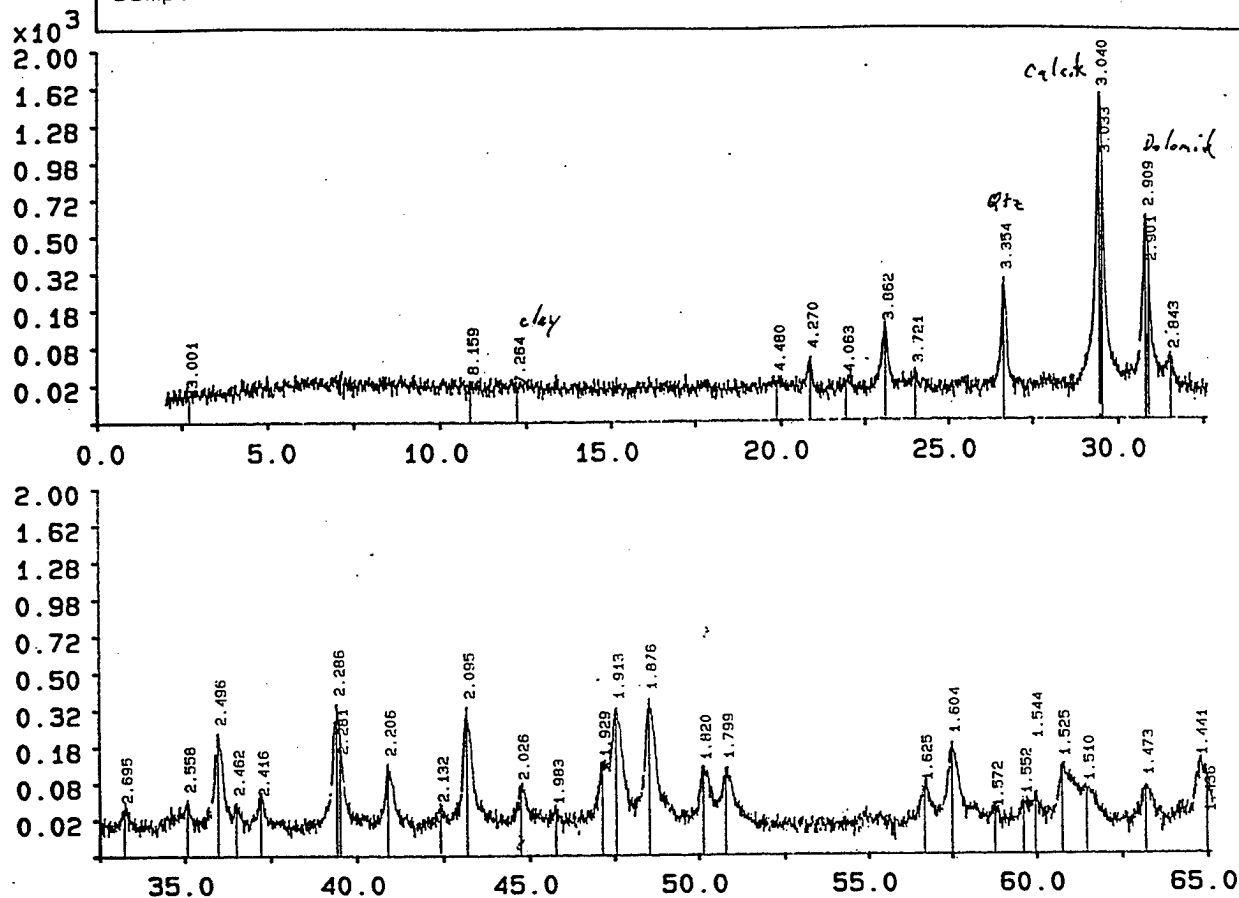
Figure 17. X-ray diffraction pattern of reactive coarse-aggregate particle from core 950628

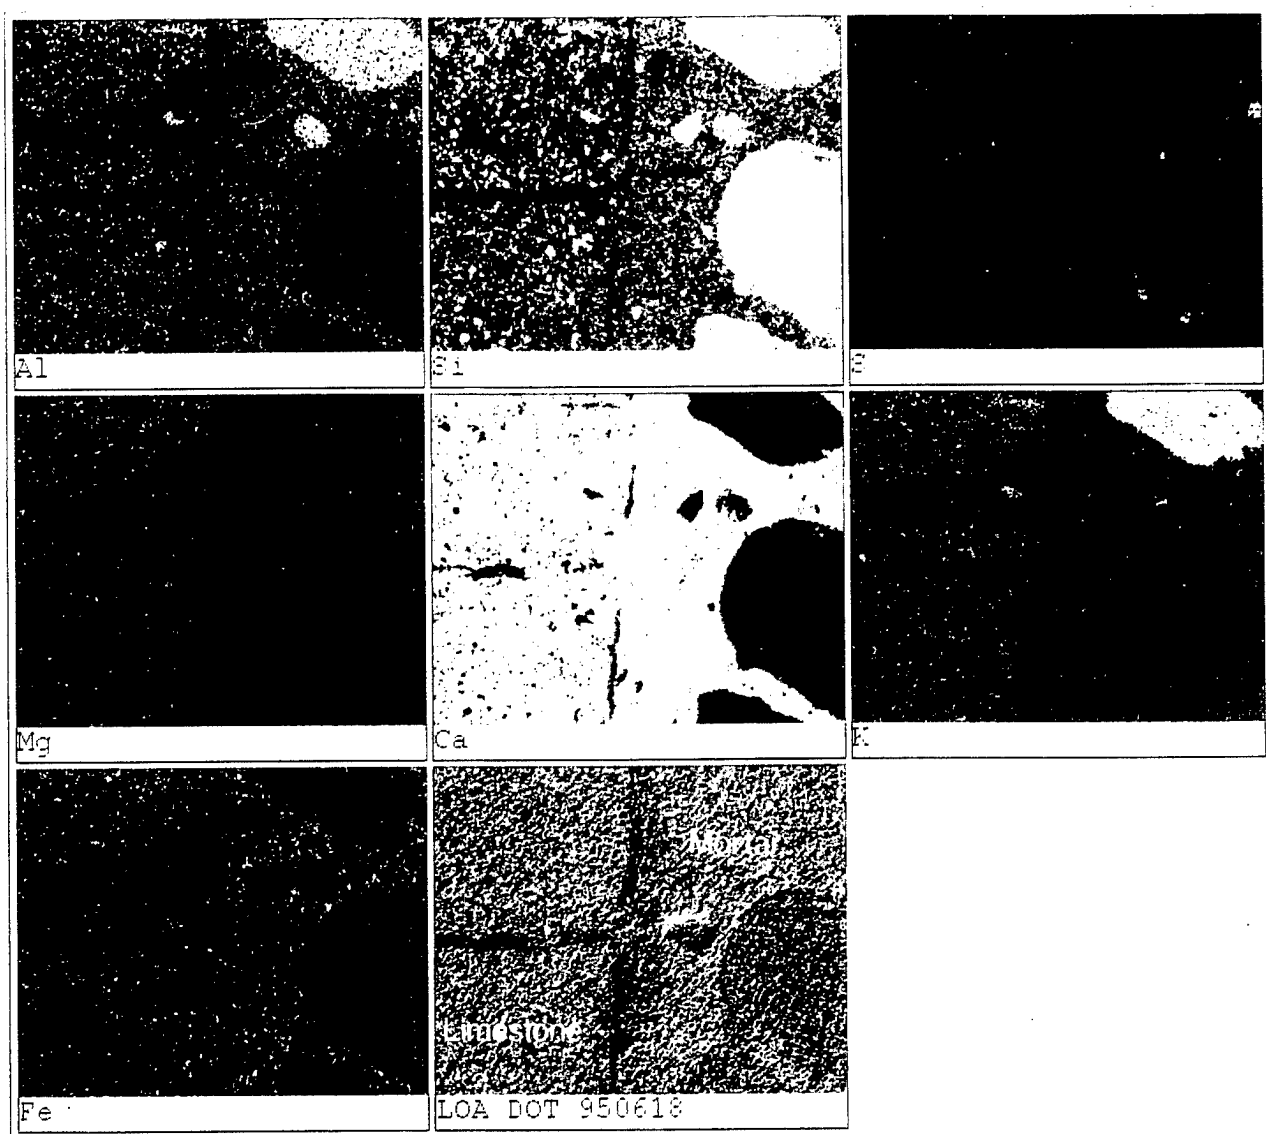
Figure 27. High-resolution X-ray elemental map of reactive coarse aggregate interface with paste.
No migration of elements is observed

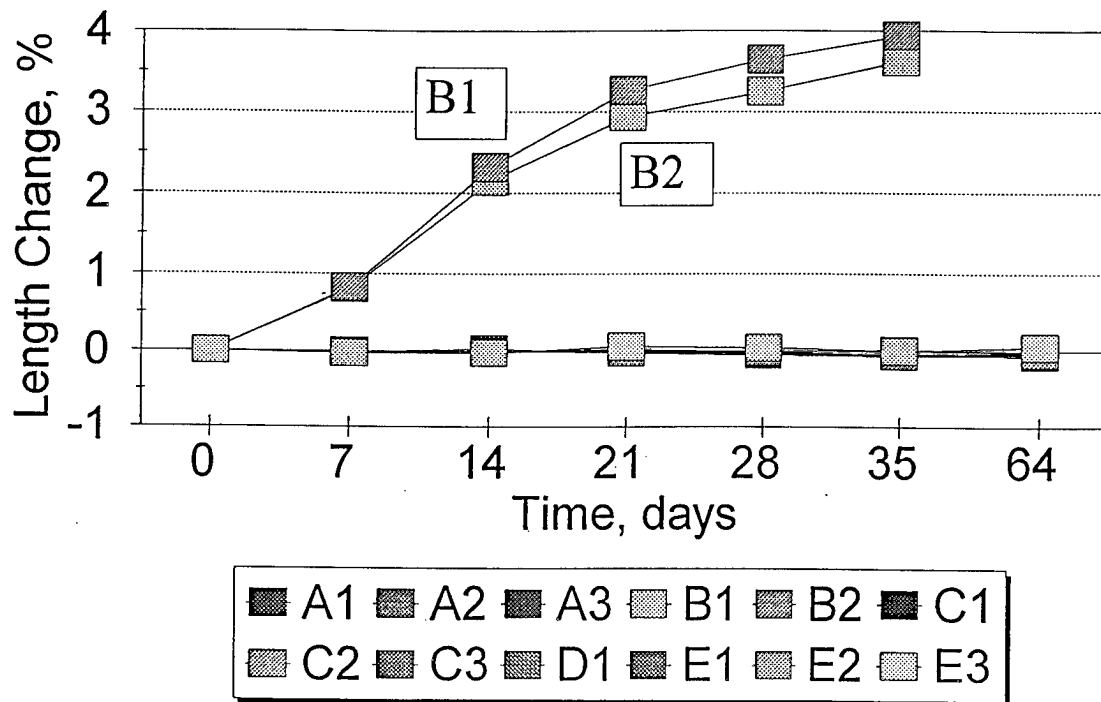
Figure 28. Rock cylinder test shows two specimens (B1 and B2) from sample 950629 expanding quickly while others did not expand. Cores were taken from five particles (A, B, C, D, and E) representing varieties of rock

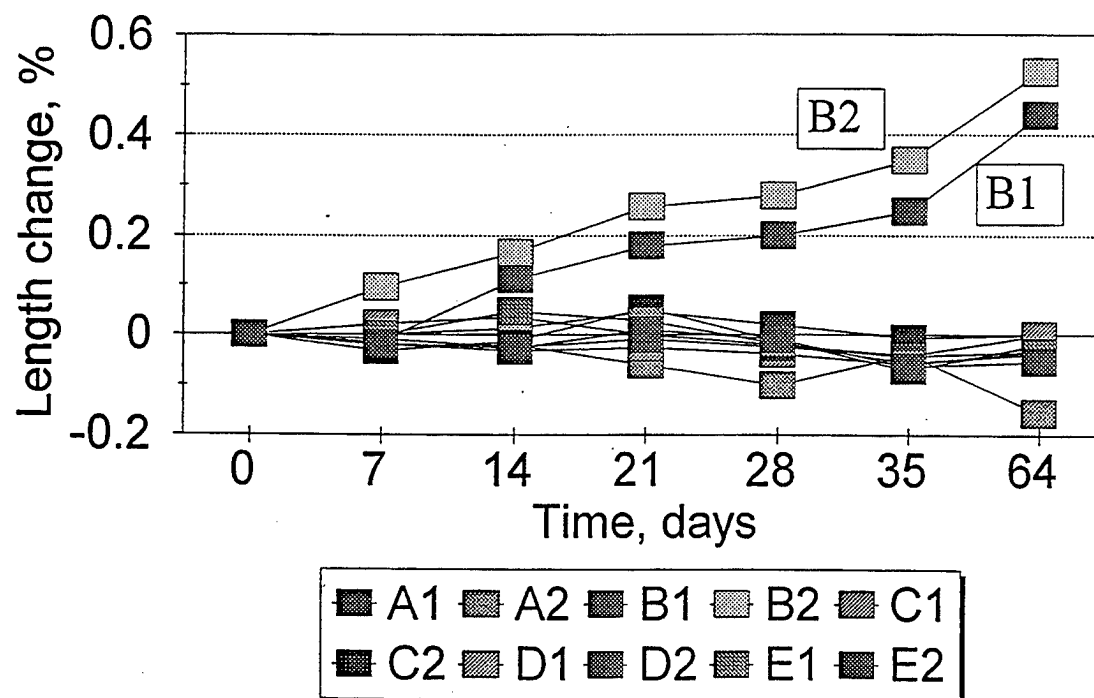
Figure 29. Rock cylinder test shows two specimens (B1 and B2) from sample 950630 expanding while others did not expand. Cores were taken from five particles (A, B, C, D, and E) representing varieties of rock

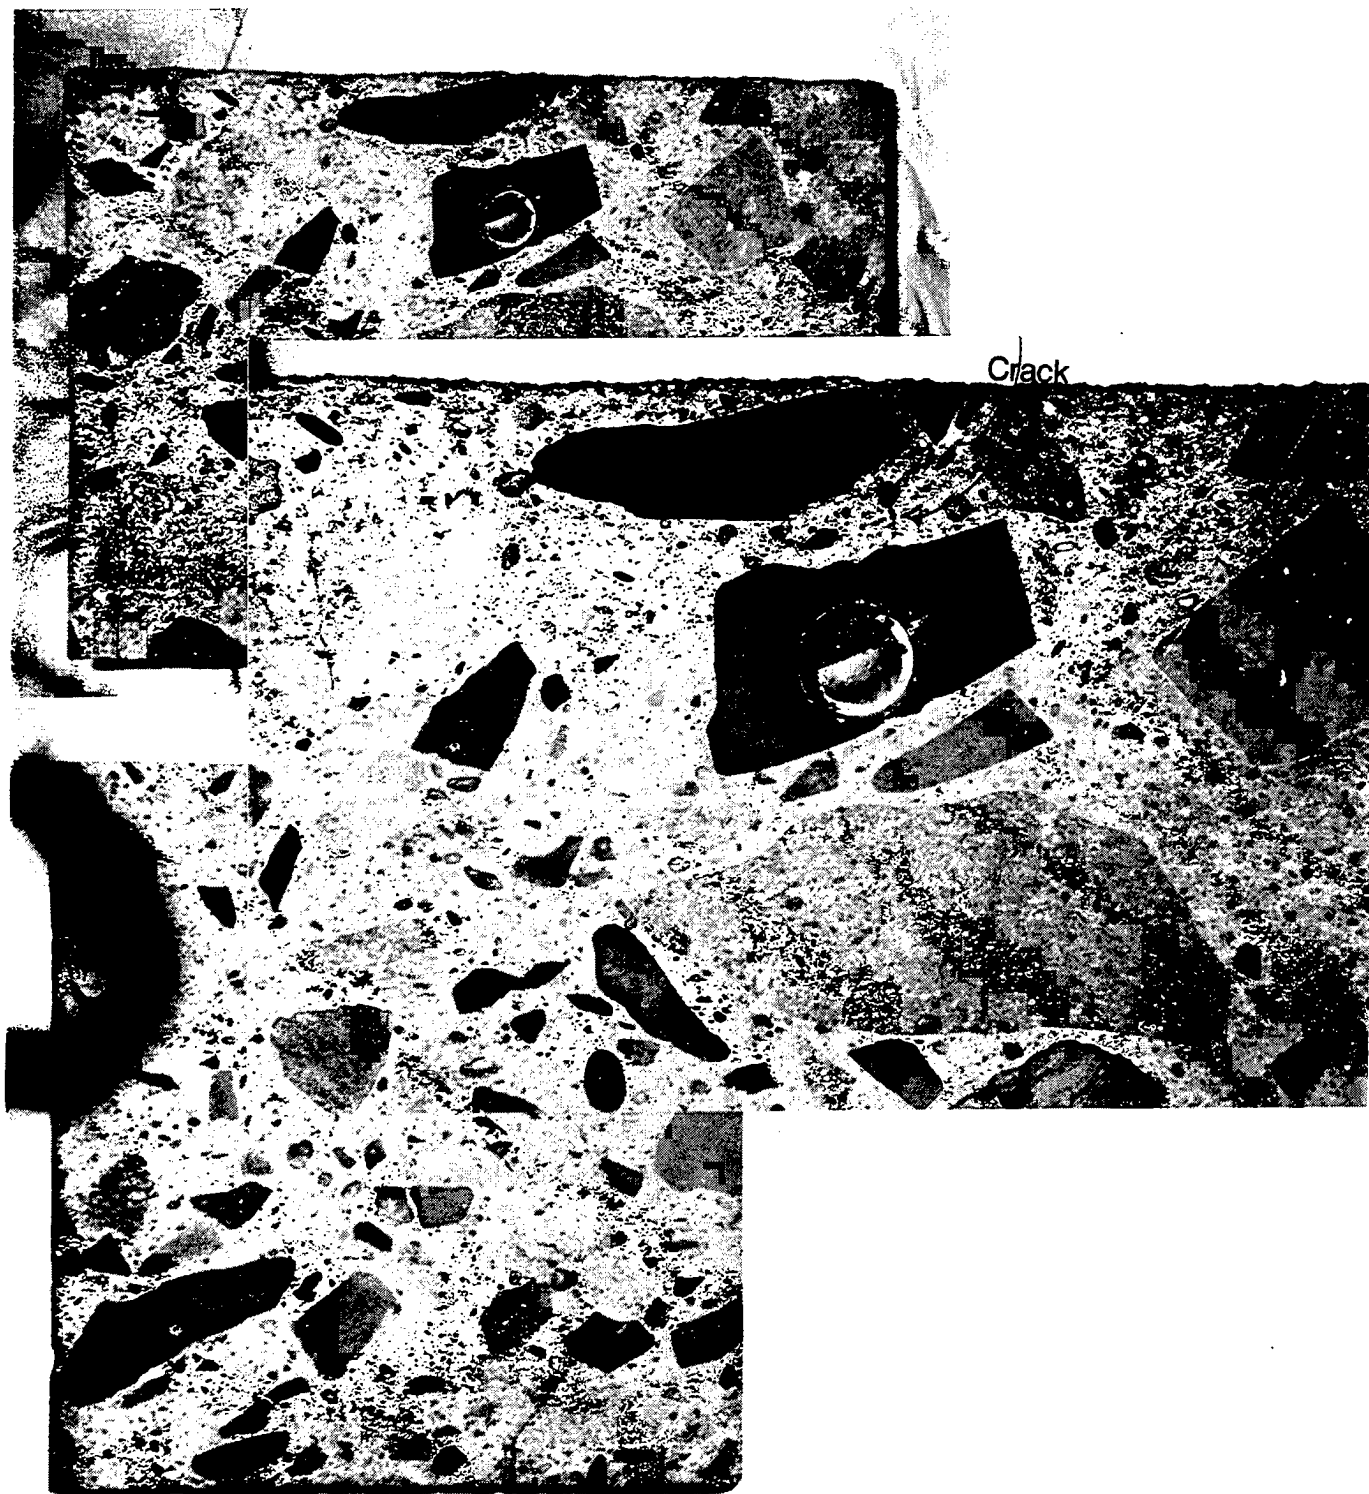
- a. 950623 - This core was cut along its entire length to expose the interior concrete. A near-surface vertical crack was associated with subsurface dark-gray coarse-aggregate particles with prominent reaction rims. These particles showed some interior cracks. X-ray diffraction examination of one particle indicated that the particle was composed of a fine-grained dolomitic limestone containing some quartz and clay, as shown in Figure 16. Some interior, randomly oriented incipient cracks were also observed associated with dark-gray coarse-aggregate particles with reaction rims, as illustrated in Figure A1, Appendix A. These cracks were located in the lower portion of the core.

Figure A1. Sample 950623 shows reactive particles 1 and 2 near top surface associated with cracks. The top and bottom samples are 6 in. (152 mm) left to right

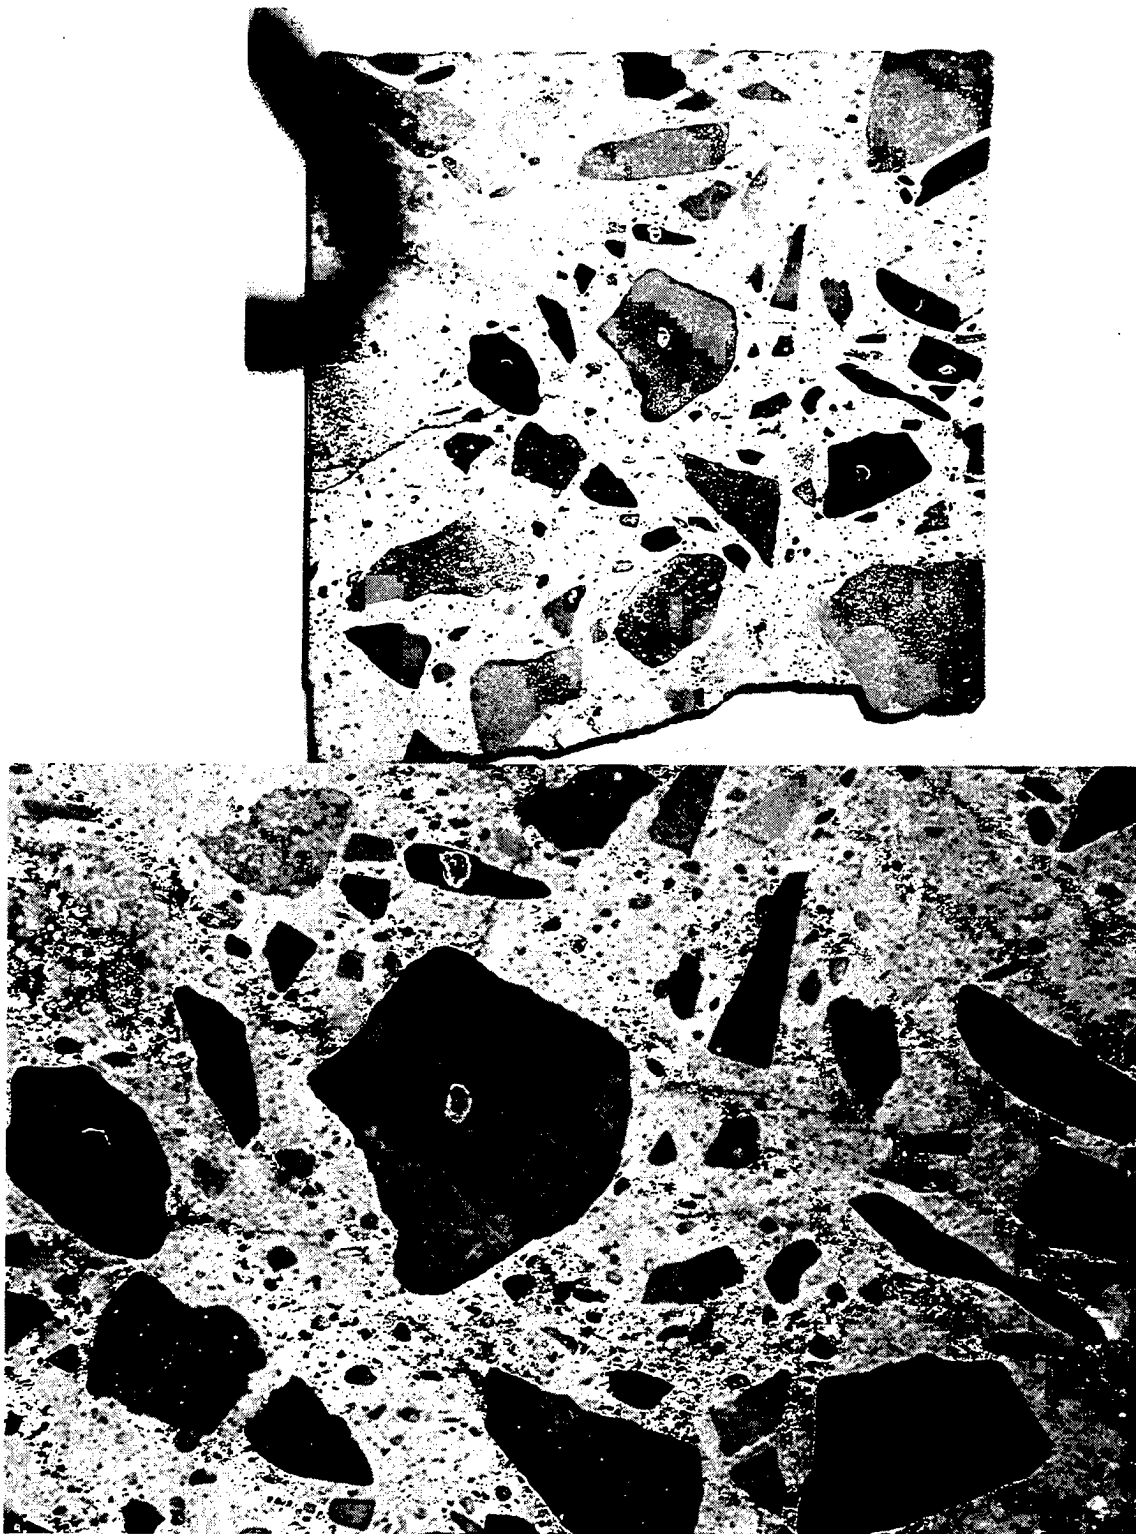
- b. 950625 - Vertical cracks from the surface intersected dark-gray coarse-aggregate particles as well as horizontal intermittent fractures, as shown in Figure A2, Appendix A. All fractures could be traced to dark-gray coarse-aggregate particles with dark reaction rims either partially or entirely rimming the particle. No cracking was associated with similar smaller dark coarse-aggregate particles. Cracks in some particles were continuous into the paste while other cracks in the aggregate particles showed no such continuation. The paste was hard and intact.

Figure A2. Sample 950623 shows a random crack pattern with cracks propagating from central reactive coarse aggregate. Other reactive aggregate particles are also present. Top sample is 6 in. (152 mm) left to right

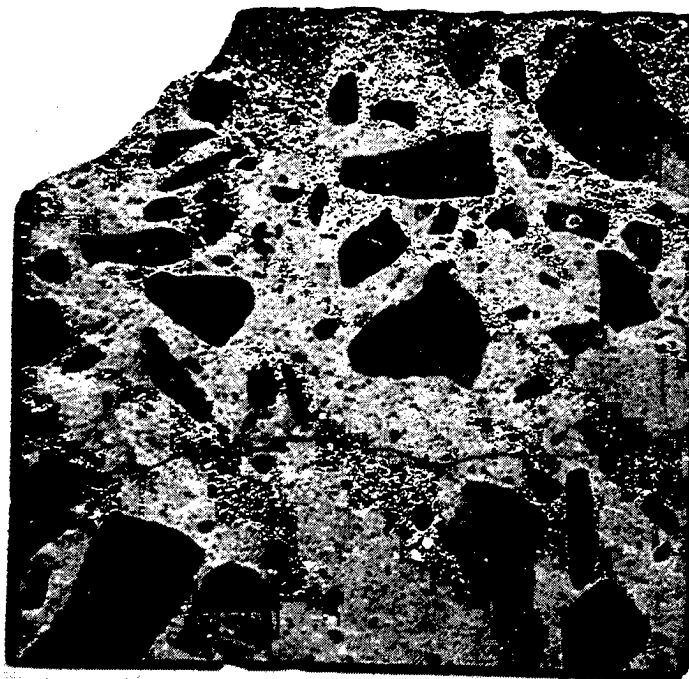
- c. 950626 - This concrete sustained localized damage. A single horizontal crack and some hairline fracturing were observed on a cut section on one side of the slab (Figure A3a, Appendix A). On the reverse side, heavy fracturing of the concrete associated with dark-gray coarse-aggregate particles was observed. Minor cracking at the bottom of the core associated with cracked dark-gray coarse aggregate is illustrated in Figure A3a, Appendix A. Examination of a thin section containing coarse-aggregate particles showed a linear opening along oriented features. The cracks contained no observed reaction products.

Figure A3a. Sample 950626 shows some interior cracking in the concrete and a few small reactive particles with reaction rims. The sample is 6 in. (152 mm) left to right

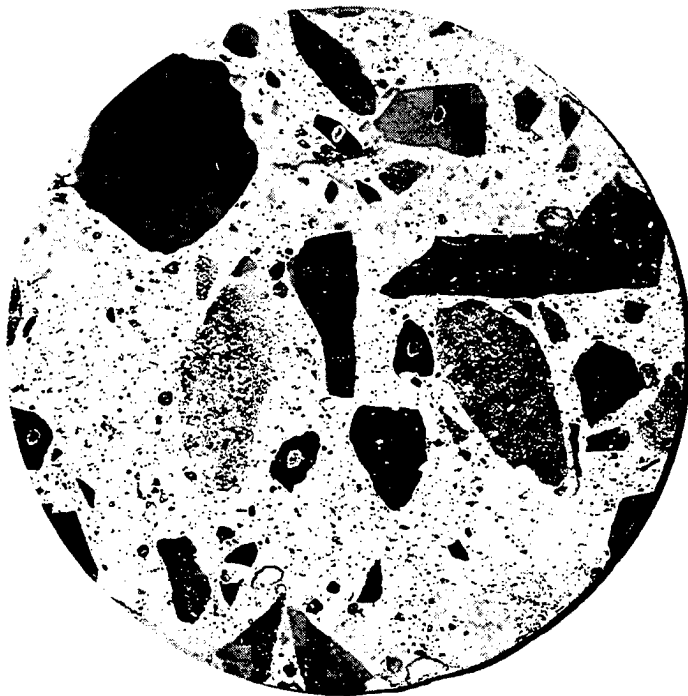
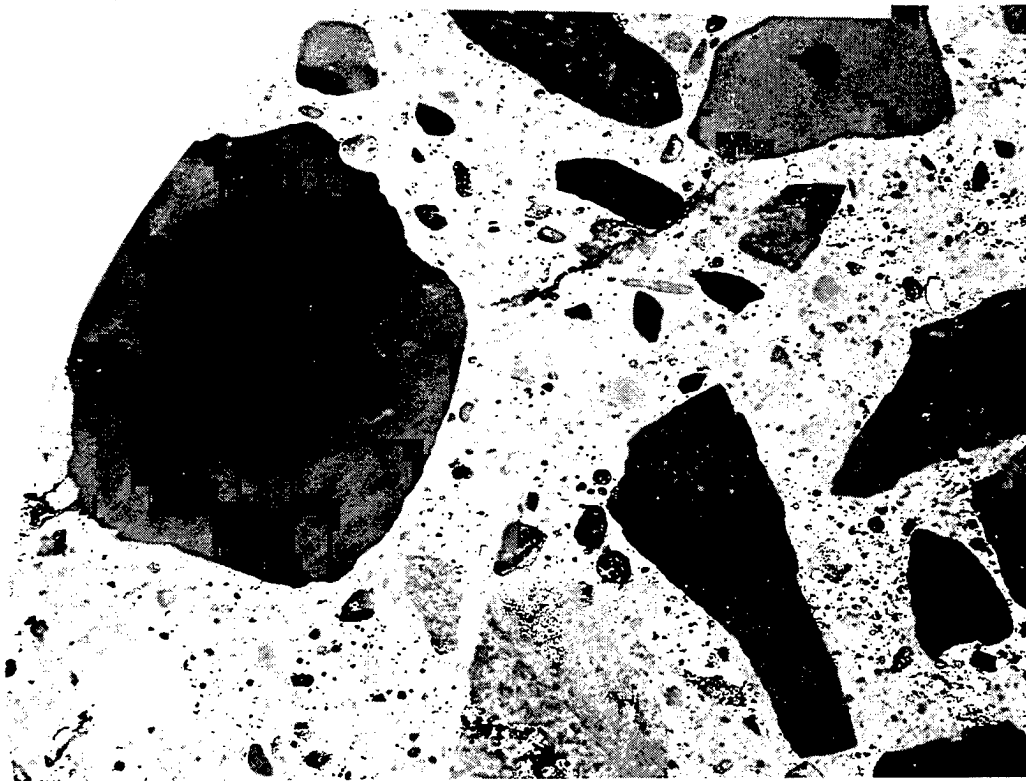
Figure A3b. Sample 950626 shows reactive aggregate particles at bottom of core. The sample is 6 in. (152 mm) left to right

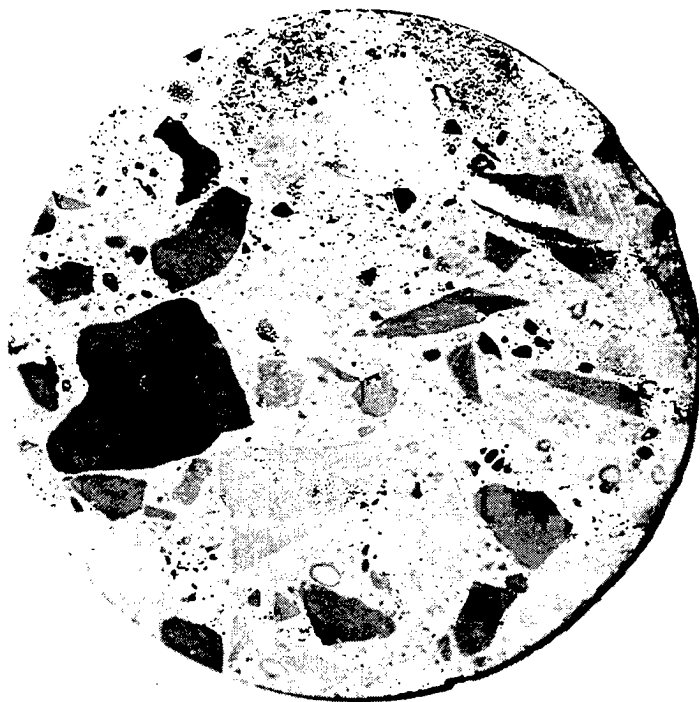
Figure A4. Sample 950627 shows no cracks. The sample is 6 in. (152 mm) left to right

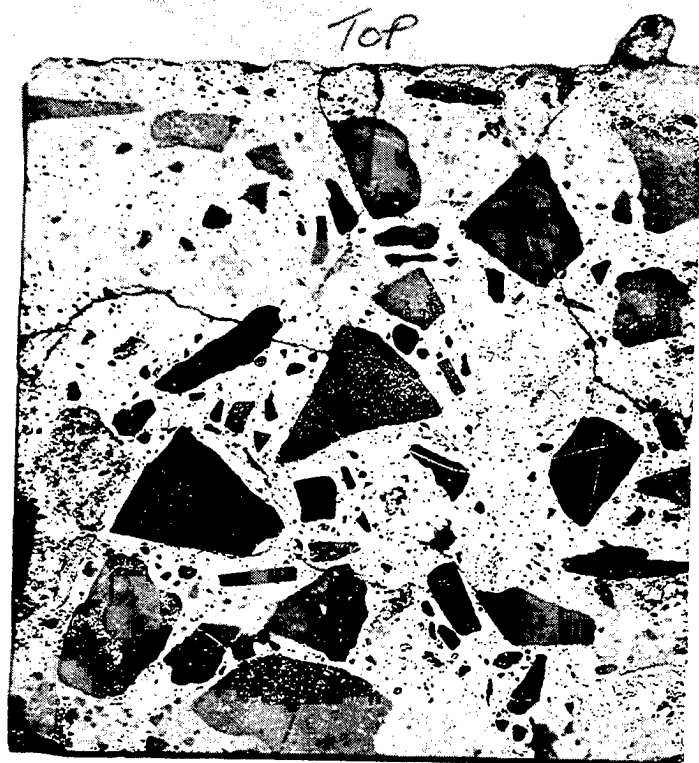
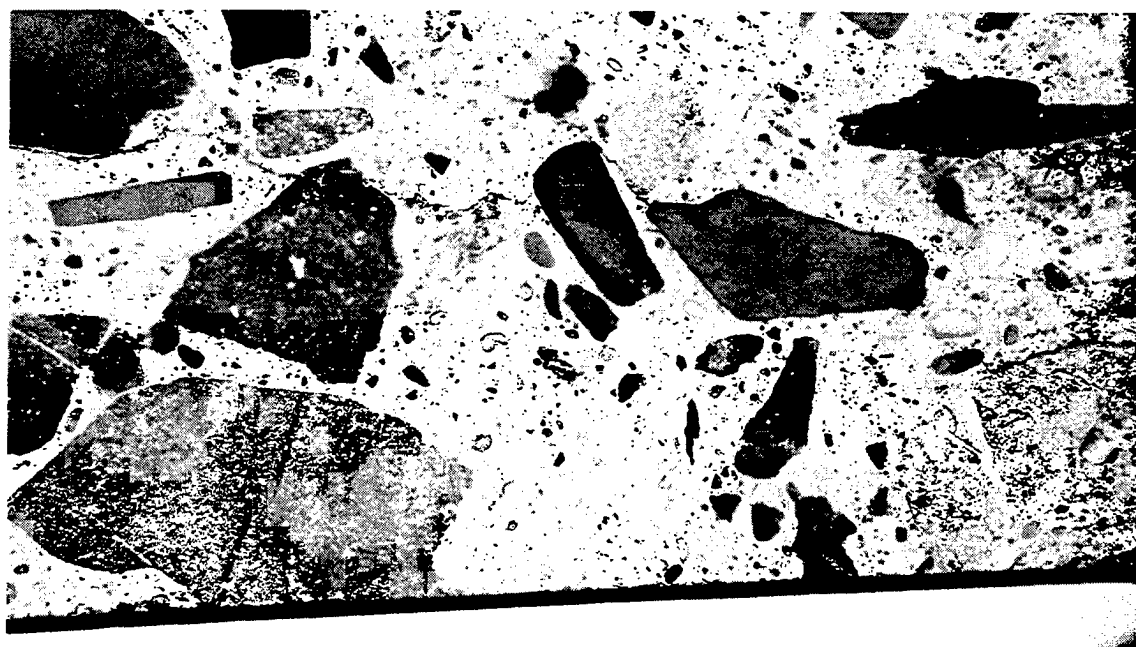
- e. 950628 - The concrete contained numerous cracks throughout the length of the core. The cracks were vertical, horizontal, and diagonal going through, as well as around, coarse-aggregate particles, as shown in Figures A5a and A5b, Appendix A. There were numerous

dark-gray fine-grained limestone coarse-aggregate particles in the concrete. Some of the pieces were large coarse-aggregate particles and some were small. Cracks were always associated with the larger pieces of aggregate of this nature and were less common with smaller pieces. Many of these pieces of aggregate showed open cracks in the interior of the particle. The X-ray diffraction pattern showed the coarse-aggregate particles to consist of a dolomitic limestone containing some quartz and clay (Figure 17).

Figure A5a. Sample 950628 shows severe cracking in near surface concrete. Epoxy resin fills the cracks. Top sample is 6 in. (152 mm) left to right

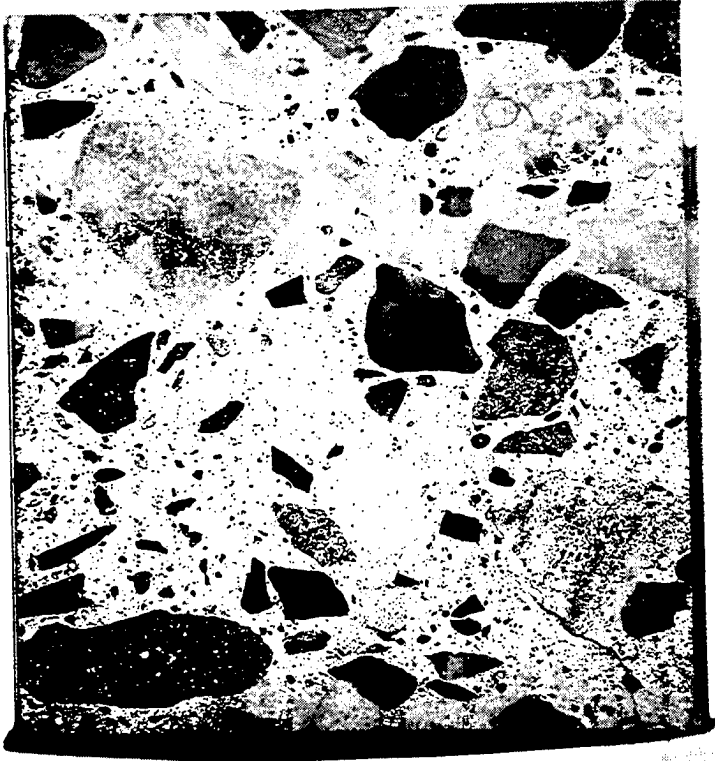
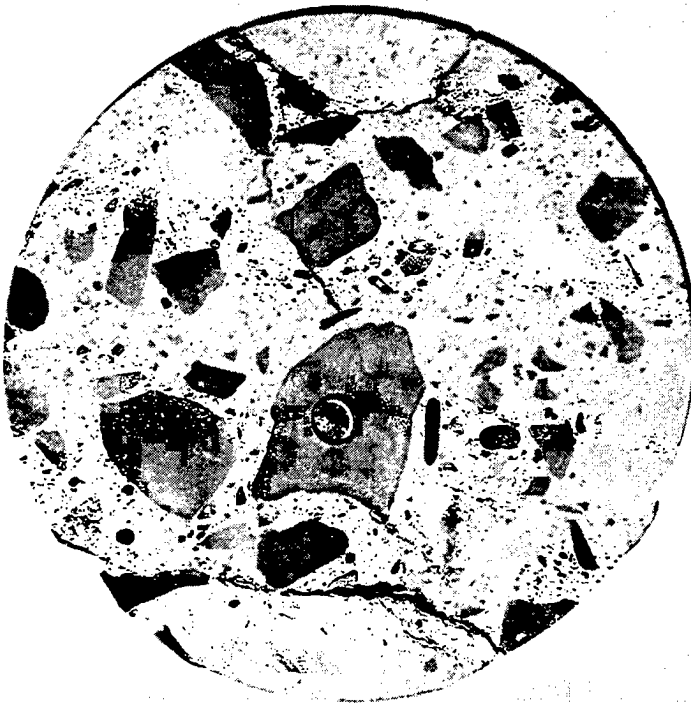
Figure A5b. Sample 950628 shows cracking is continuous throughout the entire length of core. Both samples are 6 in. (152 mm) left to right

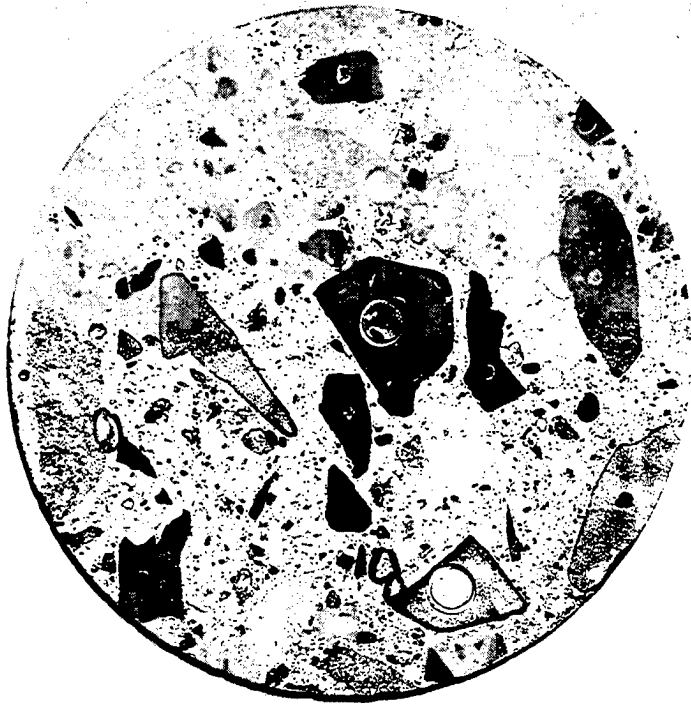
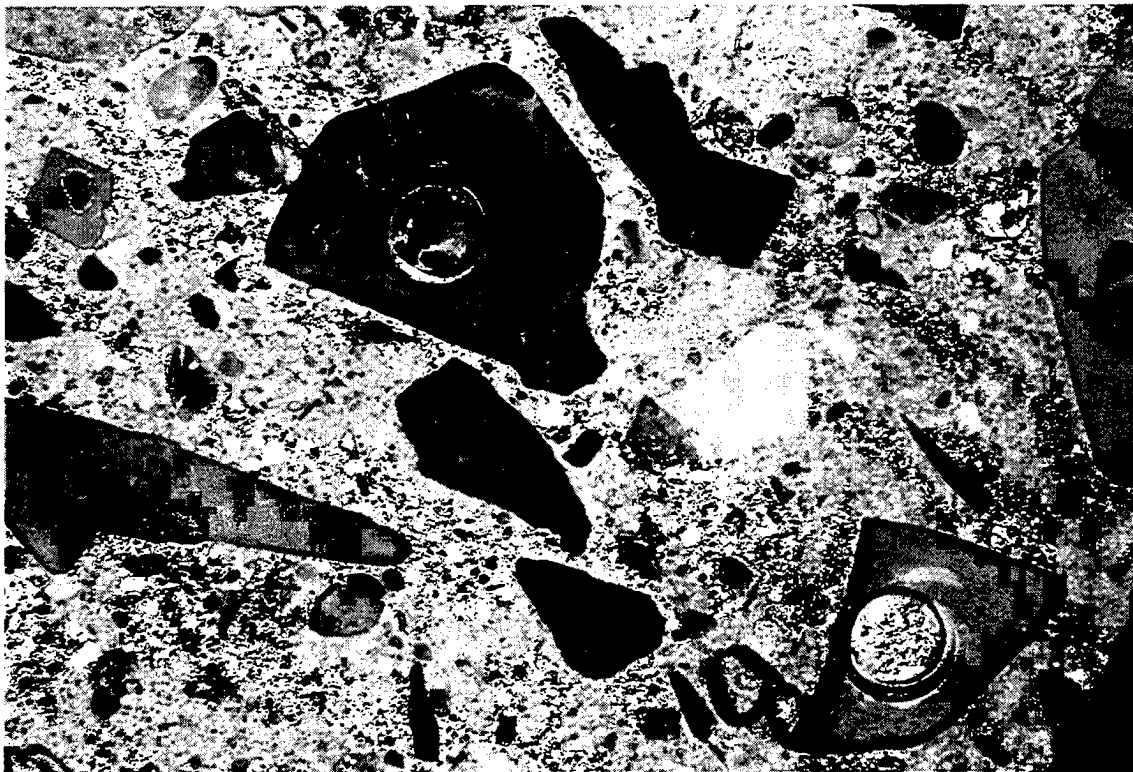
- f. 950620 - The core was cracked throughout its length. The cracks were randomly oriented. There were numerous dark-gray limestone coarse-aggregate particles with dark reaction rims. The rims exhibited radial cracks that extended into the paste. Aggregate particles with these rims were dolomitic limestone containing quartz and clay. X-ray diffraction patterns are presented in Figures 18 and 19. Figure A6, Appendix A, shows the appearance of these aggregate particles.

Figure A6. Sample 950620 shows aggregate reaction at the base of the core. Cracks are visible along the reaction rim. Top sample is 6 in. (152 mm) left to right

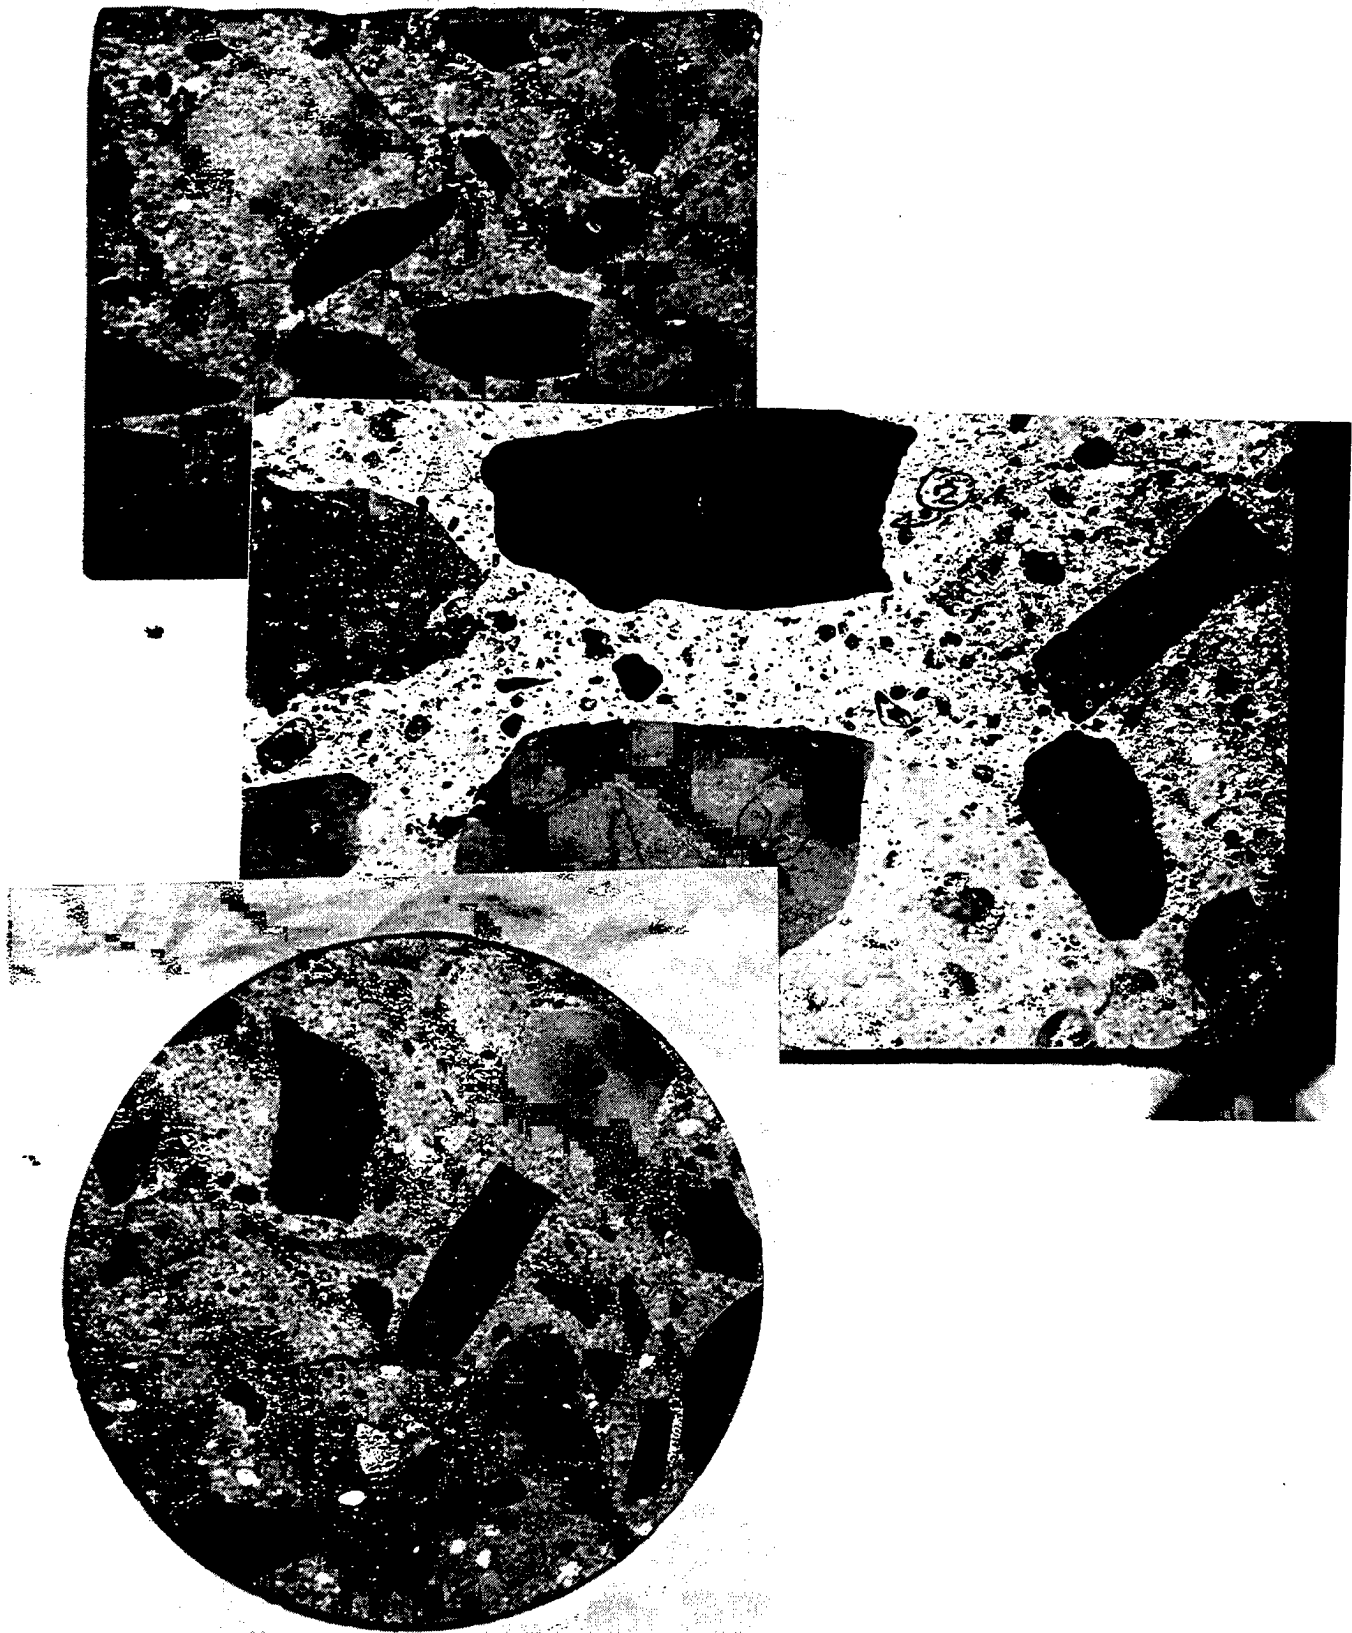
- g. 950619 - The core was cracked throughout its length. Cracking in the near-surface concrete was more severe as vertical, horizontal, and diagonal cracks were common and associated with dark-gray limestone coarse-aggregate particles (Figure A7, Appendix A). Thin sections of two coarse-aggregate particles were prepared. Particle #A was a light-colored fine-grained limestone consisting of a fine-grained matrix and rhombohedral dolomite crystals. No cracks associated with this particle were observed. Particle #B was a dark-gray fine-grained limestone with a rim around it and was associated with cracking. No difference could be observed between the material in the rim and the interior of the particle. Fine quartz grains were embedded in a calcite matrix.

Figure A7. Sample 950619 shows random crack pattern with cracks propagating from two central reactive coarse-aggregate particles and cracking in bottom end of sample. Top and bottom samples are 6 in. (152 mm) left to right

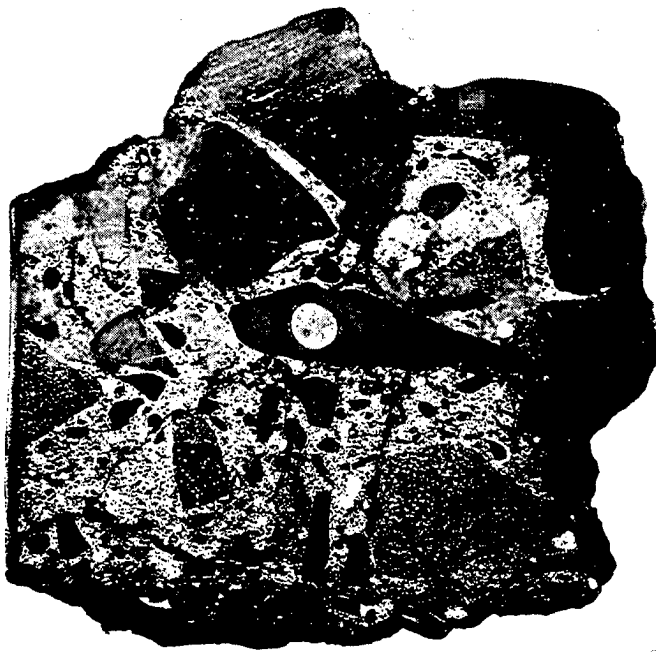
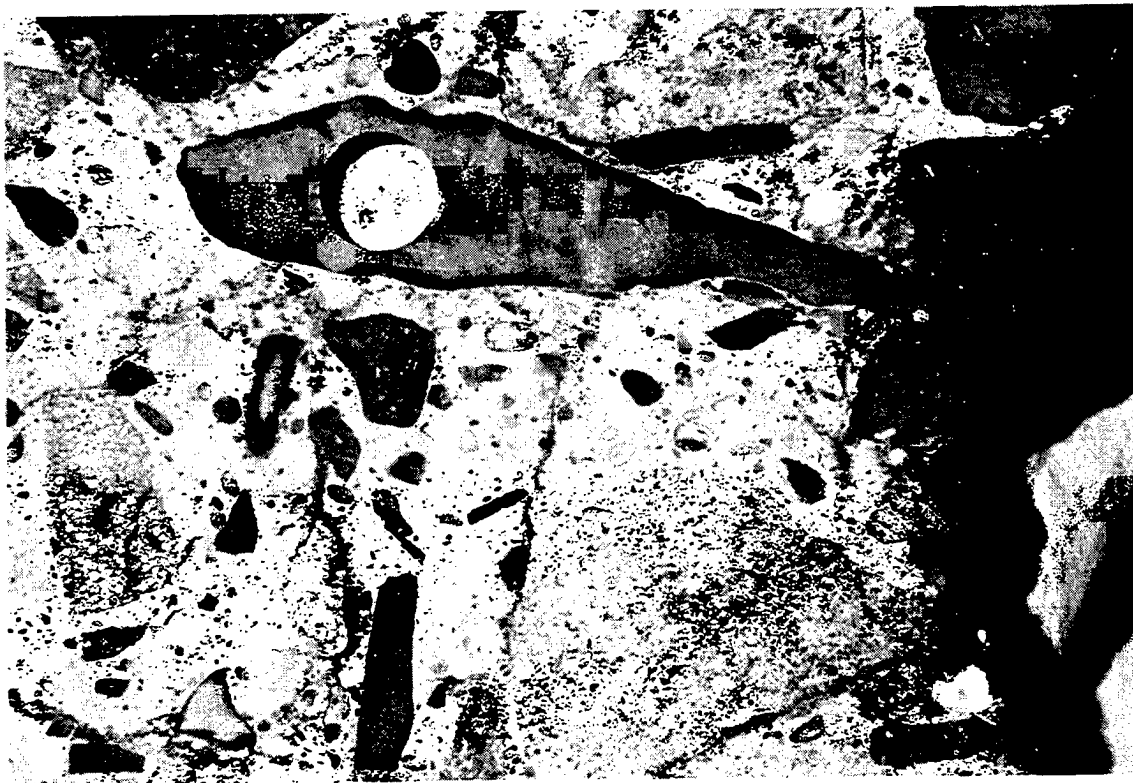
- h. 950617 - This sample consisted of rubble. The core had broken into fragments during the coring process. One large piece was impregnated using an epoxy resin and then cut open for examination. The concrete was highly fractured (Figure A8, Appendix A). There were numerous dark-gray limestone coarse-aggregate particles. Cracks were mostly associated with the larger coarse-aggregate particles. The associated dark-gray coarse-aggregate particles were dolomitic limestone containing some quartz as well as illite (clay-mica). An X-ray diffraction chart showing the relative abundance of the calcite and dolomite is presented in Figure 20.

Figure A8. Sample 950617 shows a reactive aggregate particle and cracking of rim zone. Diameter core boring is 11 mm

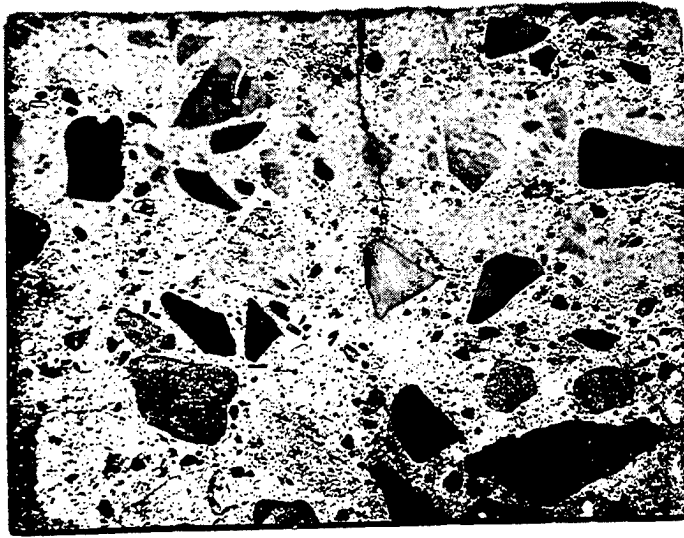
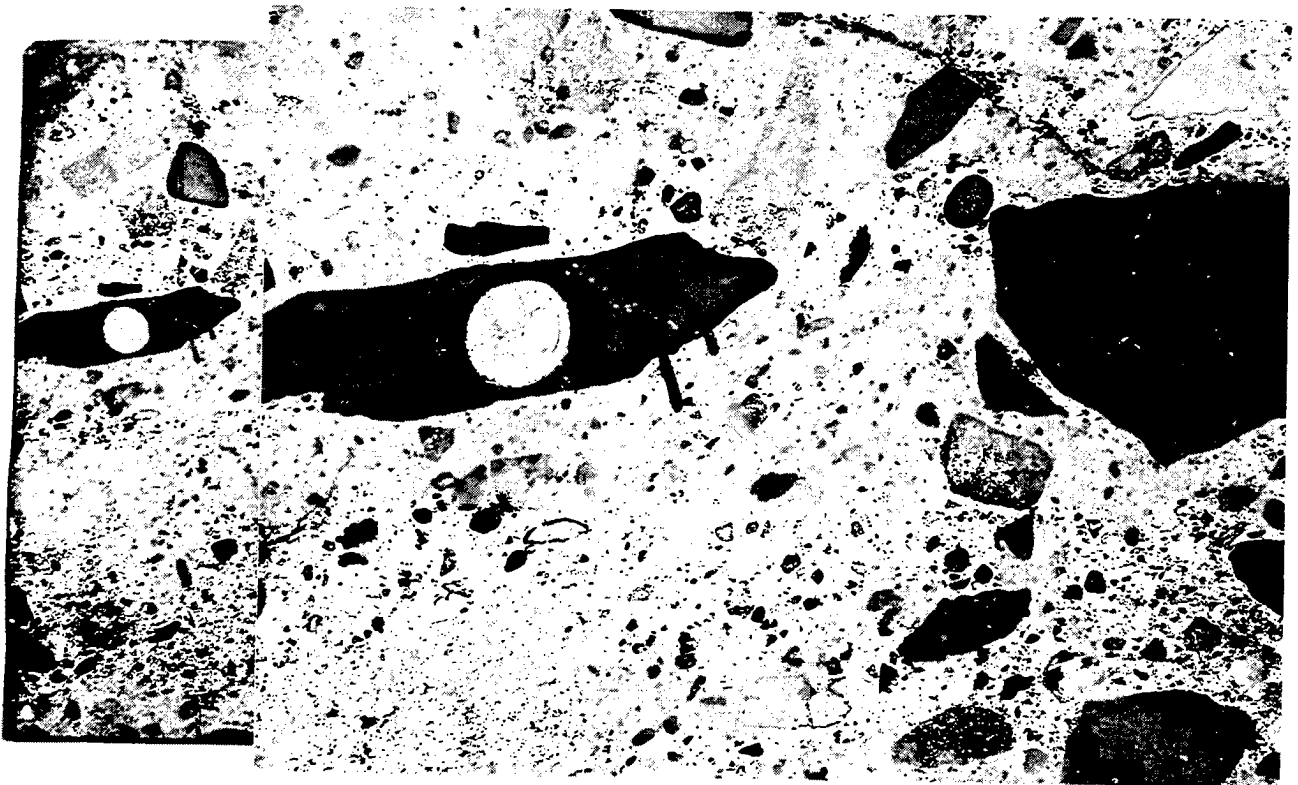
- j.* 950616 - The surface cracking was light. However, the interior concrete showed an extensive crack system. A vertical crack extended several inches into the interior concrete going through coarse-aggregate particles as well as around them. The vertical cracks intersected horizontal and diagonal cracks (Figures A9a and A9b, Appendix A). The majority of the cracks were associated with cracked dark-gray fine-grained limestone coarse-aggregate particles. Two particles examined by X-ray diffraction were dolomitic limestone with acid-insoluble materials consisting of quartz and clays. Figures 21 and 22 illustrate the relative abundance of the carbonate phases.

Figure A9a. Sample 950616 shows a central vertical near-surface crack and some incipient cracks associated with aggregate particle A. Samples on left are 6 in. (152 mm) left to right

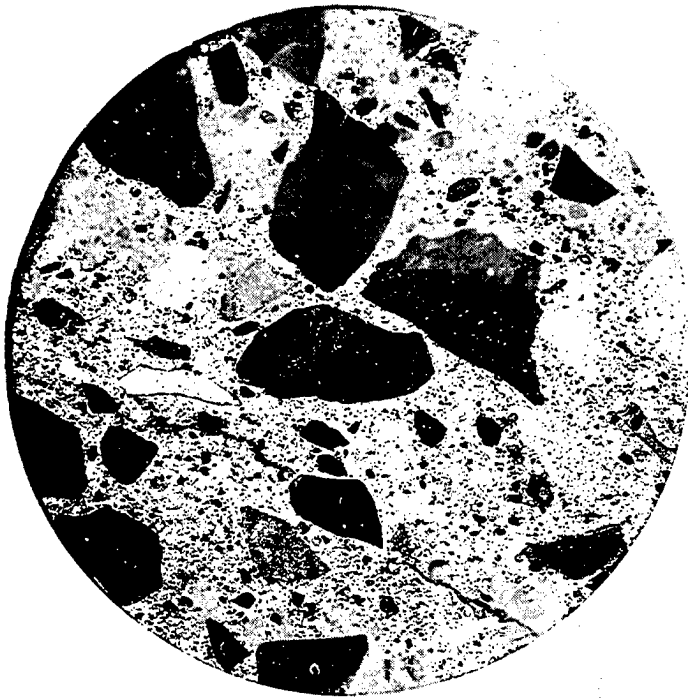
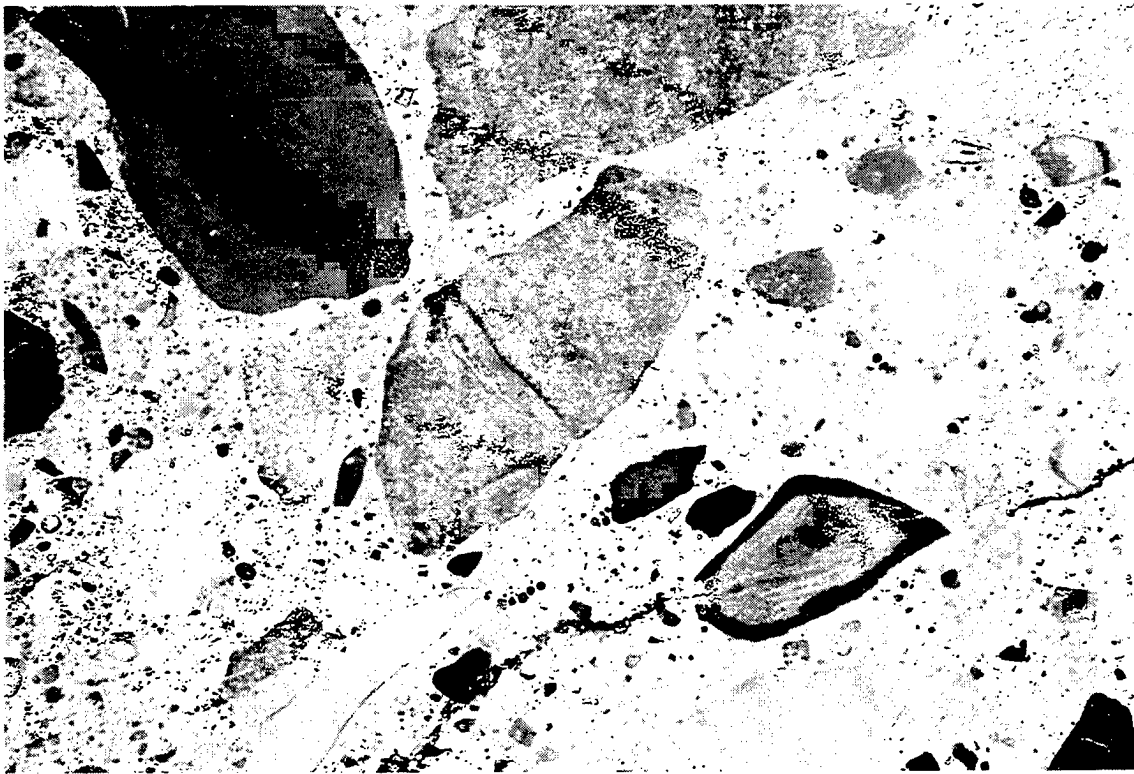
Figure A9b. Sample 950616 shows bottom of core and crack associated with reactive aggregate particle. Top sample is 6 in. (152 mm) left to right

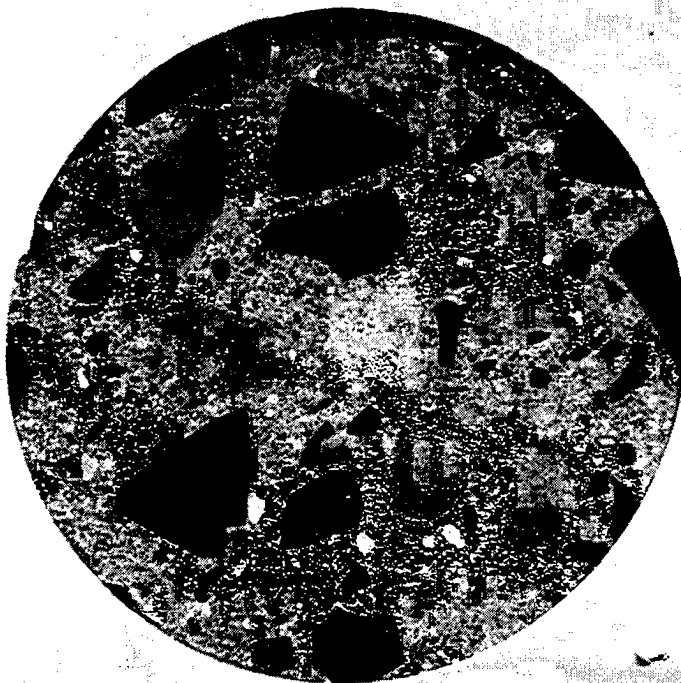
- k.* 950622 - This sample was intact with no visible cracks. The coarse aggregate was light colored and did not contain any reaction rims (Figure A10, Appendix A). A single hairline crack at the bottom of the core, shown in Figure A10, Appendix A, was observed and seems unrelated to dark-gray coarse aggregate.

Figure A10. Sample 950622 shows intact concrete with mostly light-colored aggregate particles. Bottom slice of core contains hairline crack. Both samples are 6 in. (152 mm) left to right
